REPORT OF INVESTIGATION

**Fatal Machinery Accident
February 3, 2004**

**Chas Coal, Inc.(Cont. I.D. J114)
Tyco Trucking Company, Inc. (Cont. I.D. J070)
Calvary Coal Company, Inc. (Cont. I.D. J115)**

**Calvary No. 80
Blue Diamond Coal Company, Inc.
Smilax, Leslie County, Kentucky
ID No. 15-16349**

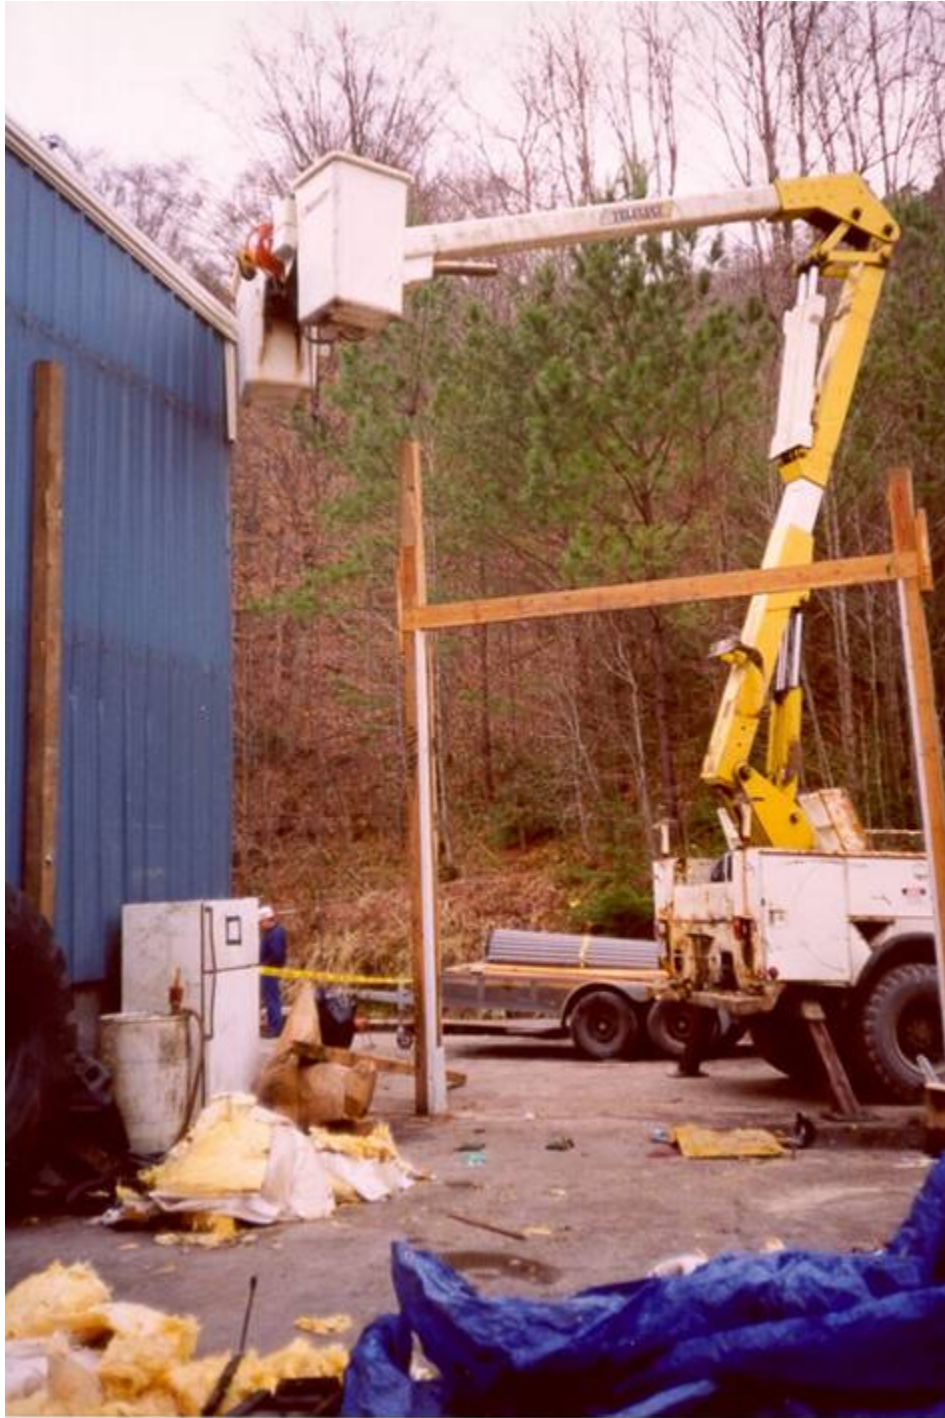
ACCIDENT SITE

This image shows the location where the accident occurred. The victim fell from the bucket to the concrete pad below. The post which was pulled, as described in this report, is lying on the cardboard box to the left.

At the time of the accident, the boom was being rotated to the left of the post, causing the fiberglass boom to be deflected downward and to the right. When the post came loose the boom holding the two baskets moved rapidly upward and to the left, throwing the victim from the basket. At the start of the accident investigation, the chain was still attached to the jib rope drum. The boom on the aerial bucket was still in the position it was after the accident. Considering the boom controls were self-centering and the victim would have been immediately ejected when the post came loose, the position of the boom after the accident was in the approximate position of the boom when the post came loose. Measurements between the boom's final position, and the post's original location indicated that the 21'-2" long chain was approximately 27" too short to be placed around the post. This indicated the fiberglass boom was deflected approximately 27" down and to the right when the post came loose from the concrete.

The fatal accident occurred because the aerial bucket truck was used improperly to lift a load. Failure to wear a safety belt or safety harness when working from a location where there was a danger of falling contributed to the severity of the accident.

Corrective Action: Mine management should establish and enforce a policy that equipment be used only in a manner consistent with the manufacturer's suggested recommendations.

Corrective Action: Mine management should establish and enforce policies and procedures to ensure that employees use safety equipment.
